## Railfuture East Anglia

### Whittlesea station audit

This report details the findings of a station audit carried out by members of Railfuture East Anglia Branch at Whittlesea Station on Thursday July 13th 2017. The audit provides a snapshot of the facilities provided at the station and the perception of rail travel given to passengers. Suggestions are made on ways to improve the passenger experience that can be taken forward by the train operator and local authorities.

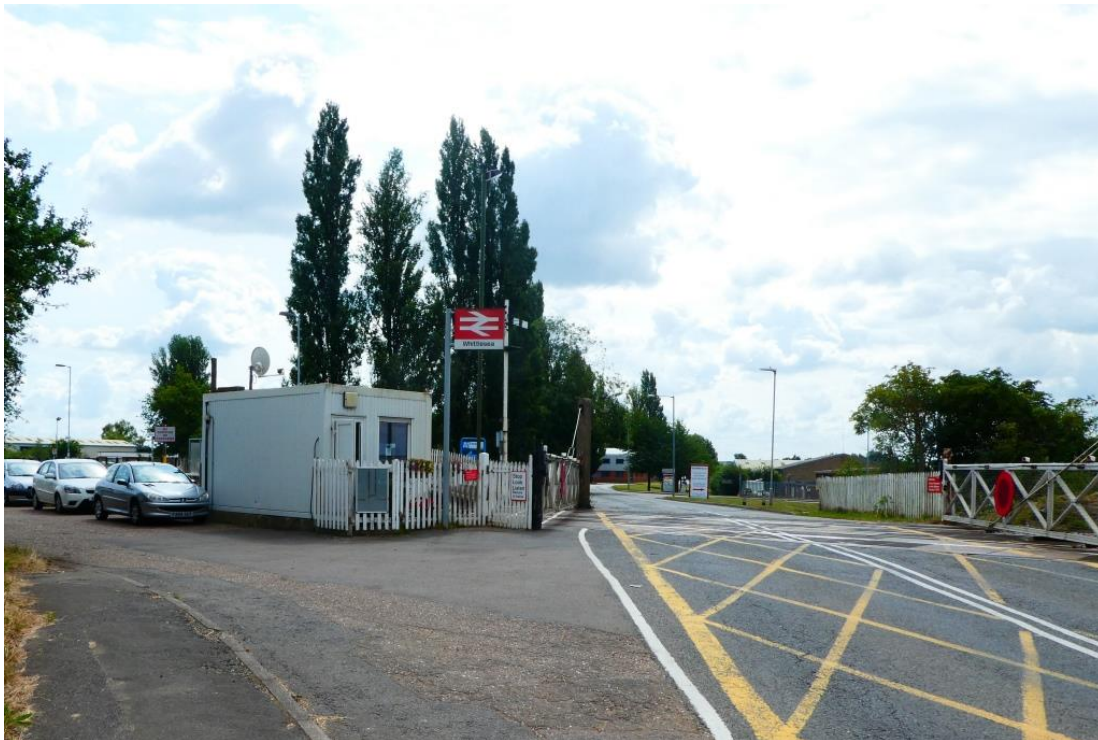
**Picture 1: Whittlesea station approach from the town centre – without the station sign would people be aware of the station?**

- Review signage on approaches to station to help promote the presence of the station and to provide better notice of the road junctions.
- Improve station visibility from the approach roads. Provide covered entrance facility to the station where local and train information, ticket machines etc. can be concentrated in one place.
- Provide better signage and maps for arriving passengers towards the town, pubs, restaurants, local specialities.
- Ensure that the road and footpath linking the station to the town centre is maintained and well lit.
- Provide additional secure and covered cycle parking on each side of the station.
- Add CCTV to the car park and platforms.
- Line out the car park spaces.
- Provide a new and well lit footpath from the up platform to the main road.

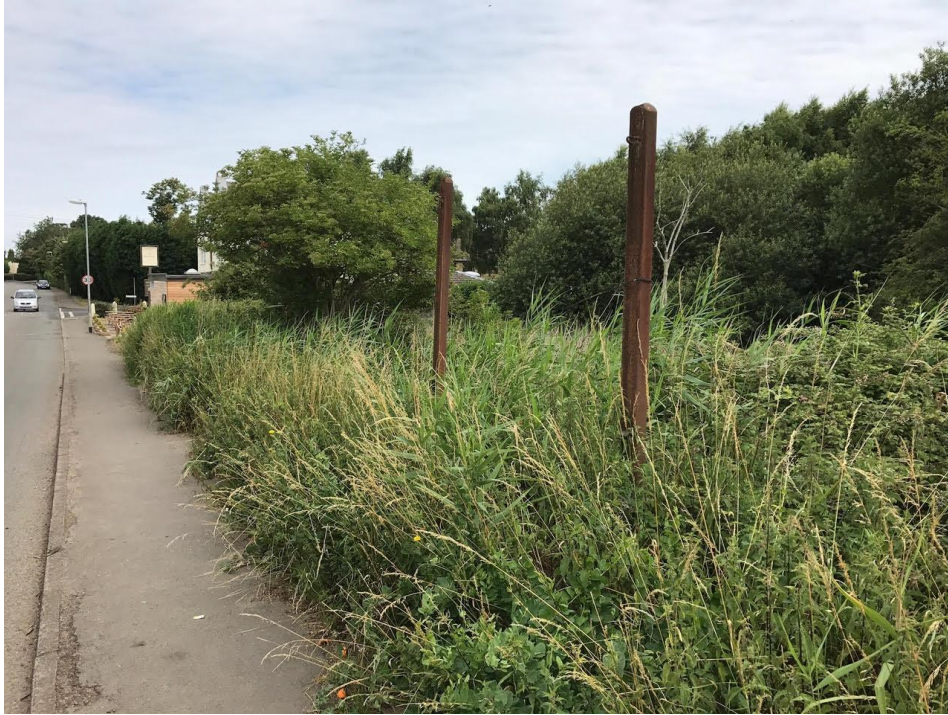
The pavement on the east side of the approach road from the town is overgrown and is starting to obstruct the route. There is also an electrical cupboard in a poor state or repair adjacent to the entrance. We understand that this area is part of the railway owned land. The area requires urgent attention.

**Picture 2: Overgrown vegetation on the pavement adjacent to the station entrance**

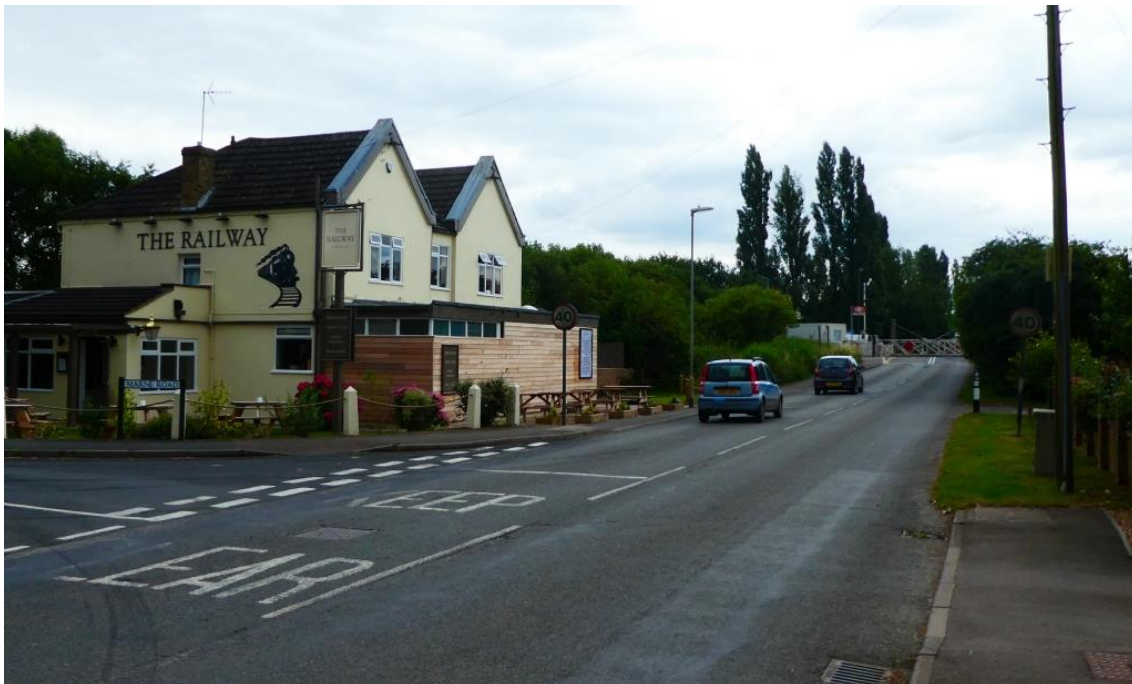
**Picture 3: The road from the town centre. The pavement on the west side stops short of the station**

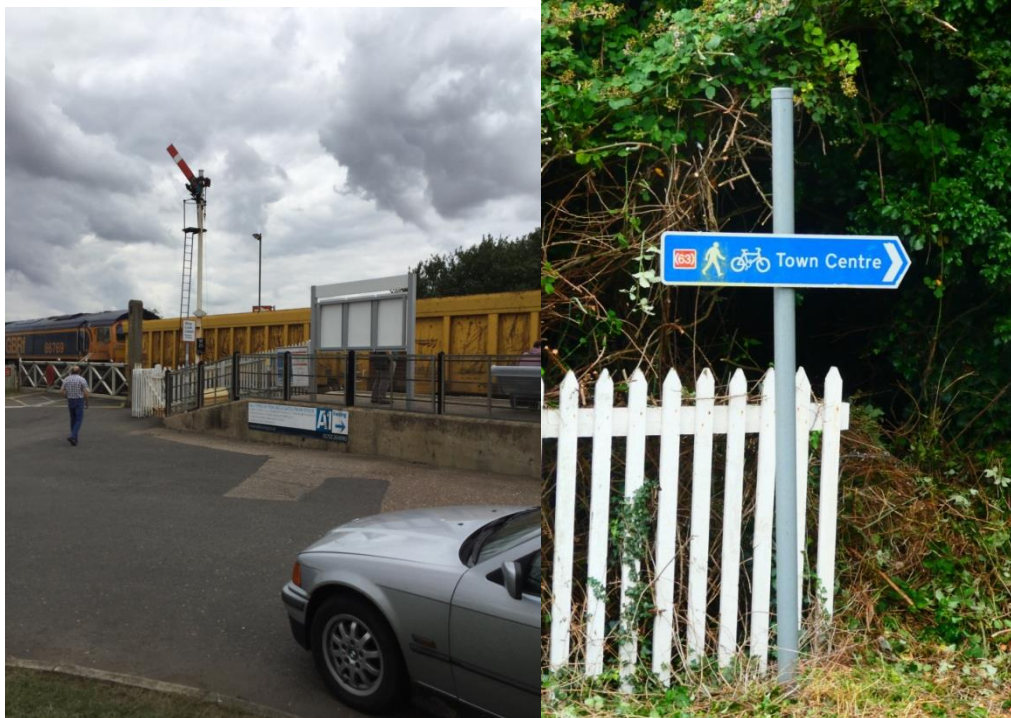
There are frequent passenger and freight trains that mean the level crossing is closed for long periods causing a build-up of vehicles that can make access to the car park a slow process. Timing of journeys to the station is therefore fraught on occasion.

**Picture 4: The level crossing is frequently closed to road traffic creating uncertainty in journey time to the station. Town direction sign by entrance**

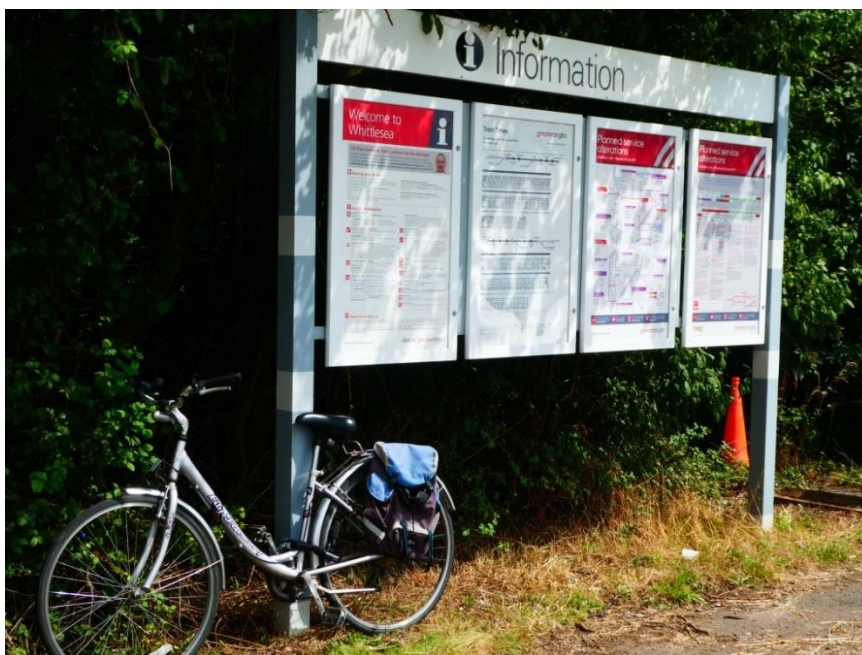
**Picture 5: There is a station information board adjacent to the road entrance**

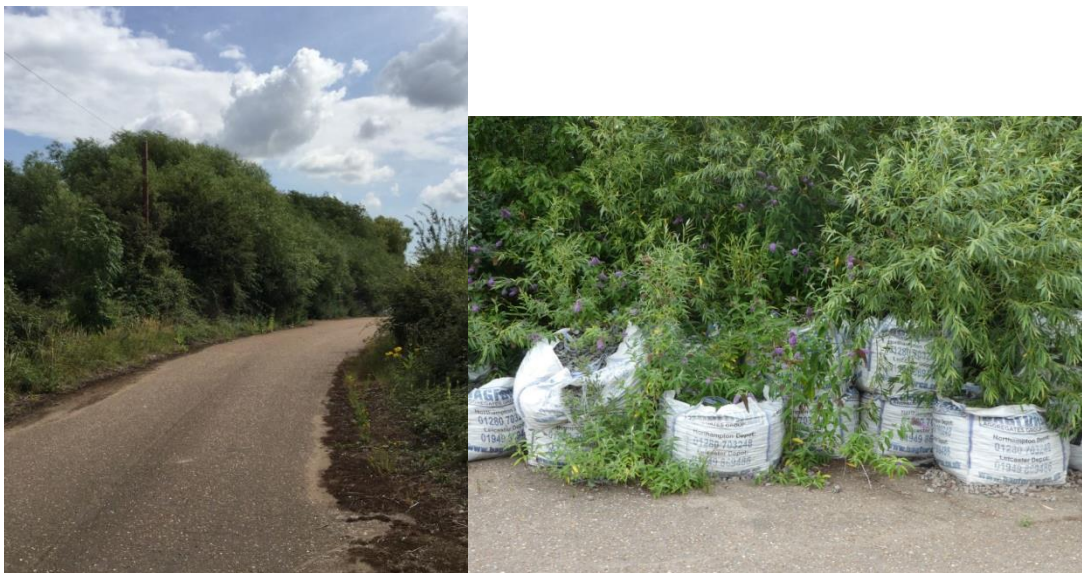
The road leading to the up platform takes at least 3 minutes to walk from the entrance gate. The north side of this road is unkempt with untended scrub trees growing alongside what appears to be an unguarded drop down into a lower level.

There is no protected walkway along the road even though HGVs visit the warehouse at the eastern extremity of the site. This untended and unmarked boundary continues all the way to a large space opposite the up platform entrance. The edge of this space is covered in many one tonne bags of spent ballast. These have been dumped, presumably by NR and are now being overgrown by the scrub.

There is no lighting alongside this overgrown 'lane'. The lack of both footpath and lighting combine to create a significant risk to passengers that needs to be addressed.

**Picture 6: Access to the up platform from the road is via an unlit shared route with no pavement. Unused ballast bags by the up platform**

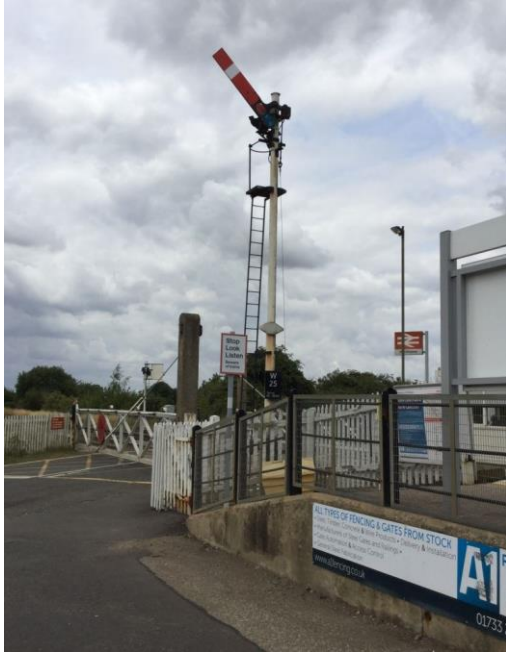
The down side platform is immediately over the level crossing, accessed by a wooden wicket gate. This is straight off the road that leads to the former south (down) side freight terminal. A play school is situated immediately beyond the station entrance. This road is well cared for. There is no pavement for passengers to stand on as they enter the station.

**Picture 7: The entrance to the down platform showing steep ramp and direct access onto the road**

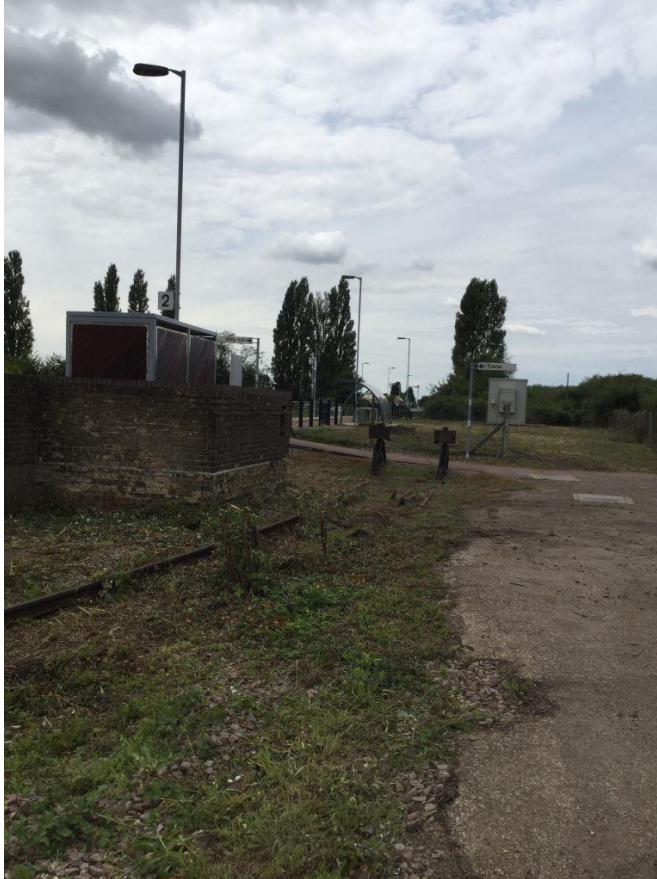
Access to the platform is by a footpath from the overgrown 'square' just before the warehouse entrance. The ramp to the platform does not meet DDA requirements as it is too steep.

Picture 8: Access to the up platform. The wall around the waiting shelter is in a poor state of repair

The only passenger shelter is provided by a tiny box-like structure that has a low two seater bench inside, naturally lit through a perplex wall. There is no electric light inside. The wall around the shelter is in a poor condition and needs urgent attention. Three tall columns provide lighting along the platform.

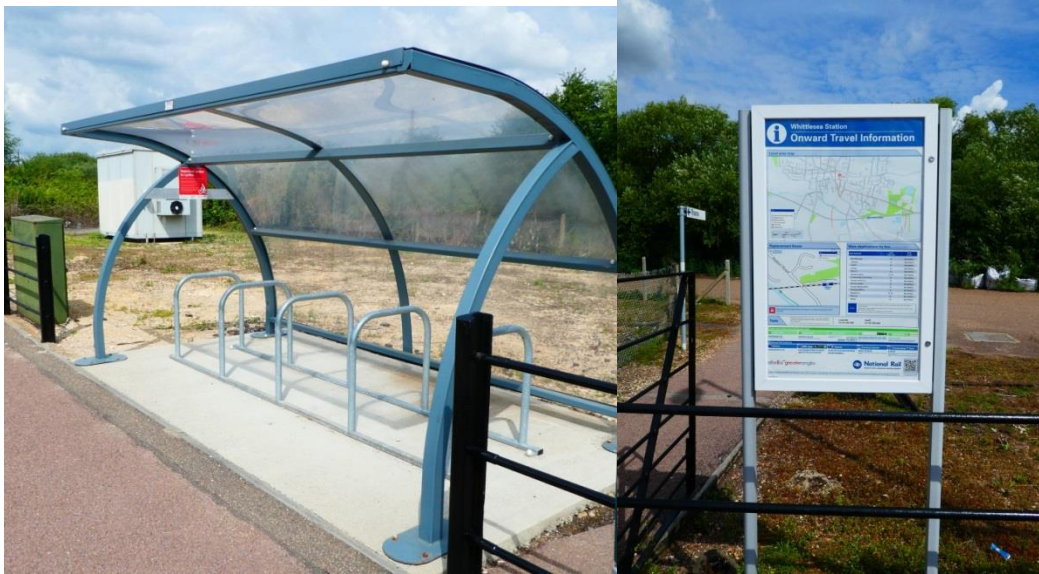
A new covered bicycle shed with space for 10 cycles secured to 5 Sheffield stands has been provided. There were no cycles in it though one was secured to the information boards at the station entrance. This reflects the walking distance between the platforms.

**Picture 9: Up platform facilities: the unused cycle shelter, information board.**

- Remove cycle racks from the up platform and relocate near station entrance near main road. Unsurprisingly they are not used as whichever direction the user is going to, there will be 3 to 4 minute long unproductive walk to collect or place the bike on the up platform.
- Provide larger and lit platform shelters on each platform with seating
- Review signage to provide a clear way marked route to and from the town centre.
- Provide platform customer information screens on both platforms.
- The TOC should consult closely with the CRP as to the location of ticket vending machines when these are installed.

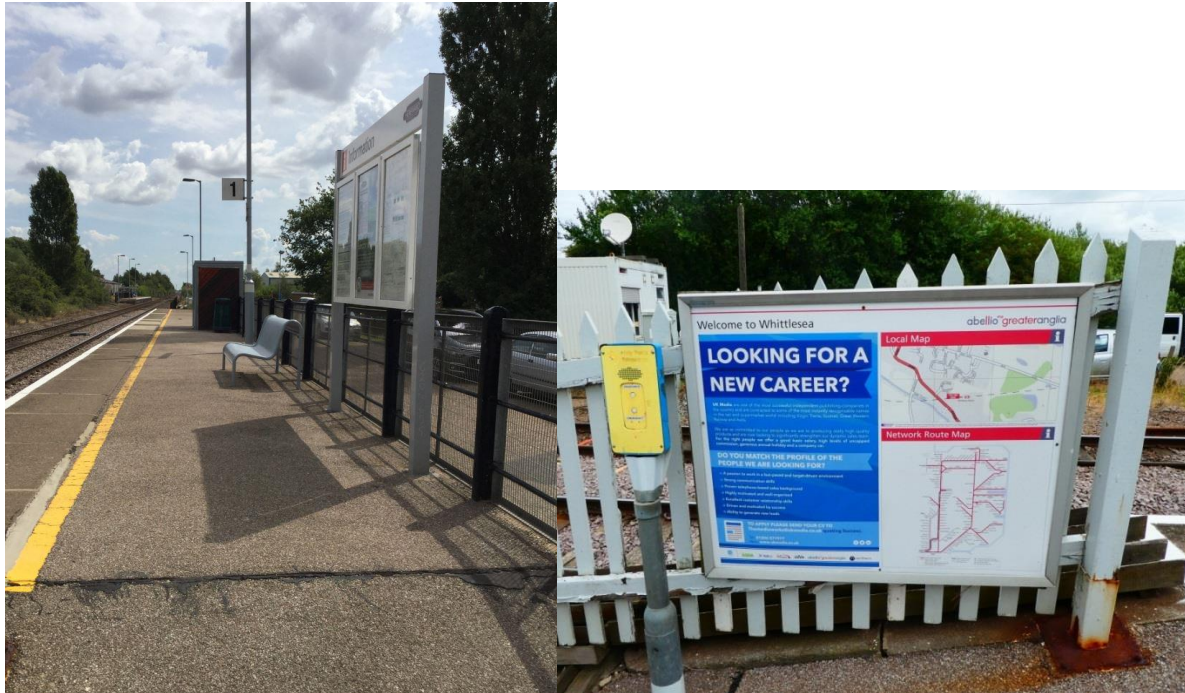
The down platform has a slightly more positive feel to it. It is located at the level crossing. As the level crossing is worked by a crossing keeper 24/7, there is always a human presence nearby. The ramp to the platform is also too steep to meet Equality Act compliance and is partially obstructed by signage posts. The gate at the end of the ramp leads directly onto the road.

**Picture 10: The down platform and information board**

This platform has a similar shelter to the upside and one low platform seat. Again, no lighting within the shelter. The platform is adequately lit by three tall columns. Information is neatly presented/concentrated at the platform entrance opposite the wicket gate and on the platform. The right-angled bend at the foot of the ramp provides an additional hazard for wheelchair and passengers with buggies.
