## Railfuture East Anglia

### Whittlesford Parkway station audit

This report details the findings of a station audit carried out by members of Railfuture East Anglia Branch at Whittlesford Parkway Station on Wednesday 23 November 2016.

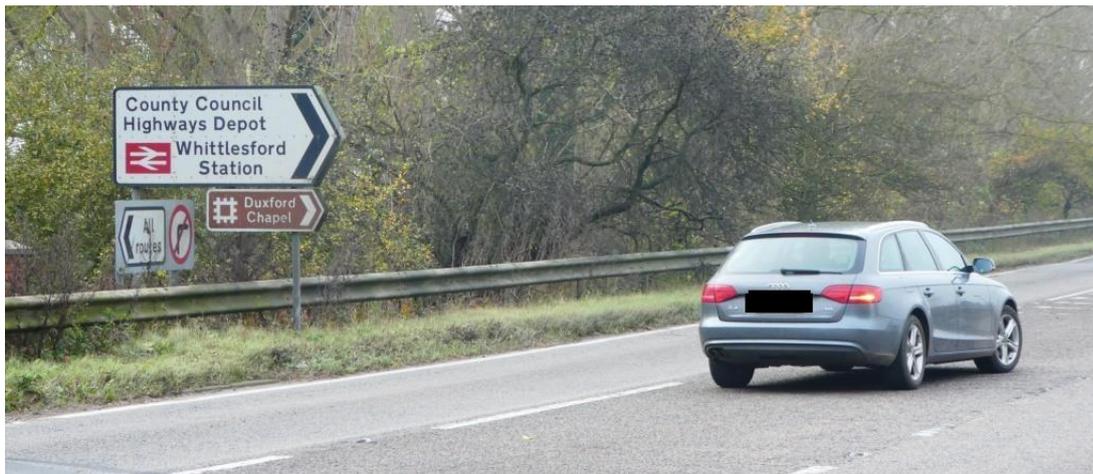
The main road access to the station and car park (320 spaces) is on the east side with a junction off the A505 road. Although there is a sign at the junction, there is no advanced warning on the road for approaching drivers. A turning lane is provided for motorists from the east. There is a no right turn for drivers leaving the station approach road, so they are required to turn left and turn around at the roundabout 500m away. Road markings are worn and unclear. During the visit, we saw a motorist ignoring this restriction.

**Picture 1: Access to the east station car park from the A505. A turning lane is provided. More advanced warning of the junction could be provided.**

- Review signage on approaches to station including new signage to help promote the presence of the station and to provide better notice of the road junctions. Signs to the station should be provided in adjacent villages. Signage for car users should be different than that for cyclists. The road network around the station is very "managed" with few direct routes available.

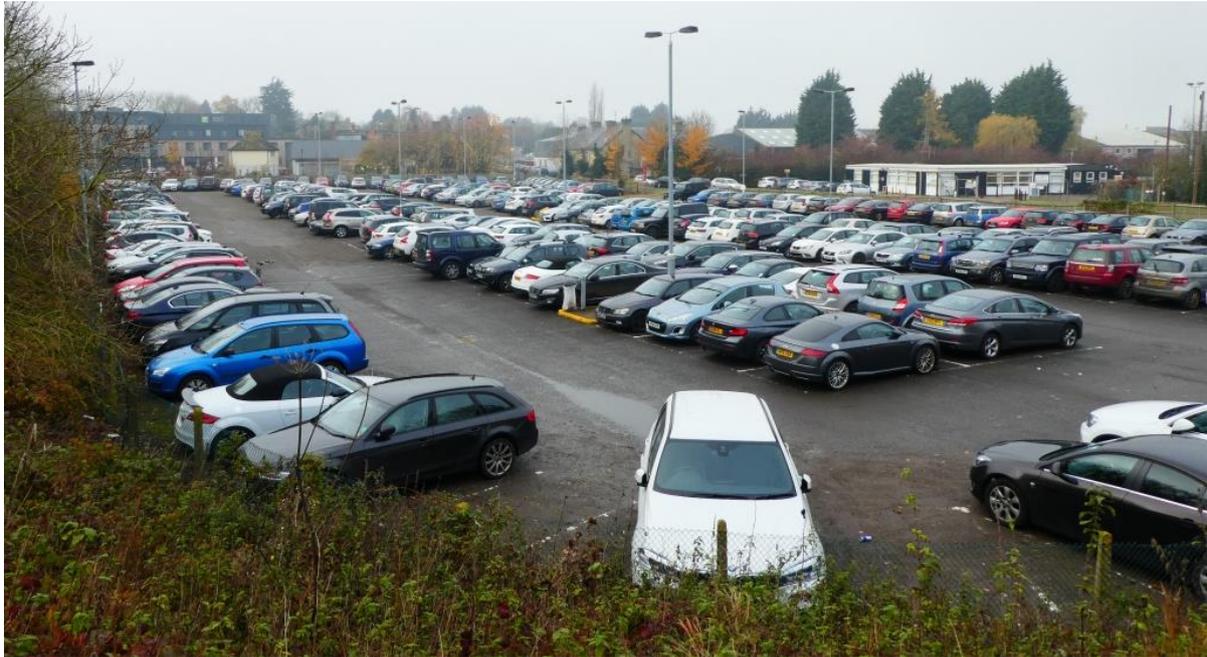
There is only a single ticket machine in the east car park meaning that many passengers have to walk some distance to buy a ticket and then return to their car. Although passengers can pay by phone, the instructions were not clear and dwarfed by the long list of parking regulations.

**Picture 2(A): The east car park with few available spaces at 11.00. Additional ticket machines are required. Could a revised parking layout increase the number of spaces available?**

- Additional ticket machines in the car park. The new structures could include a kiosk/coffee shop.
- Add CCTV to the car park.
- Reline the car park spaces. There are wide gaps between parking rows which may allow an additional row (50 spaces) to be added especially if part of the grass verge could be used. Plan to provide a deck over the car park.

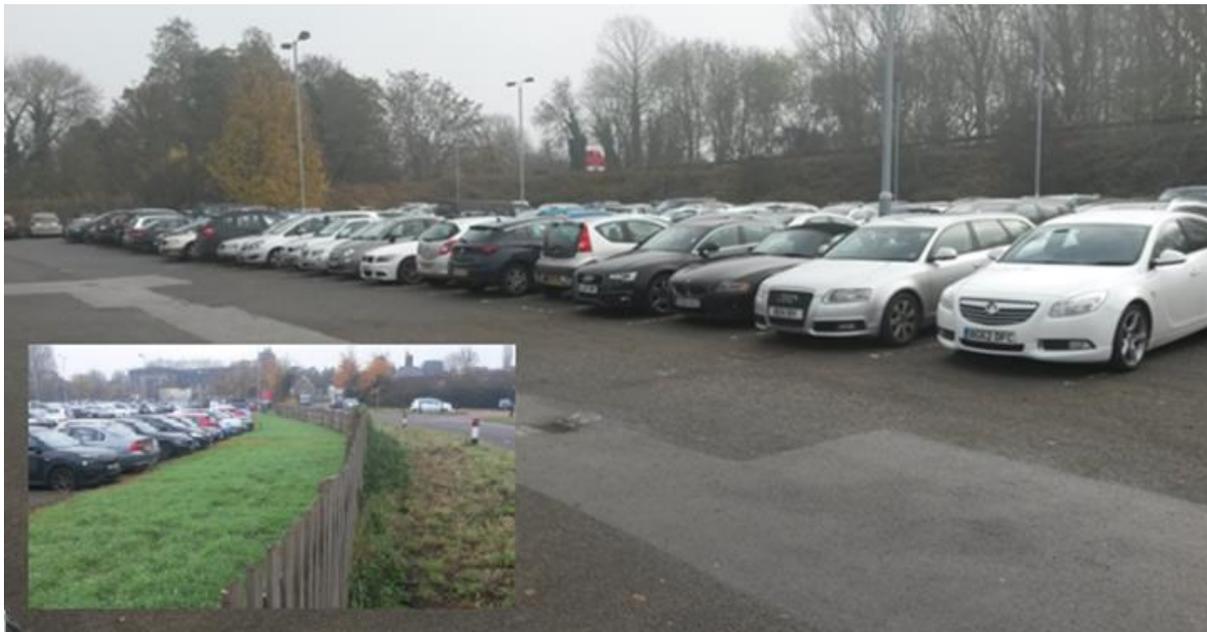
**Picture 2(B): A lot of space in the car park is wasted. Some of the grassed area (inset picture) could also be used for parking.**

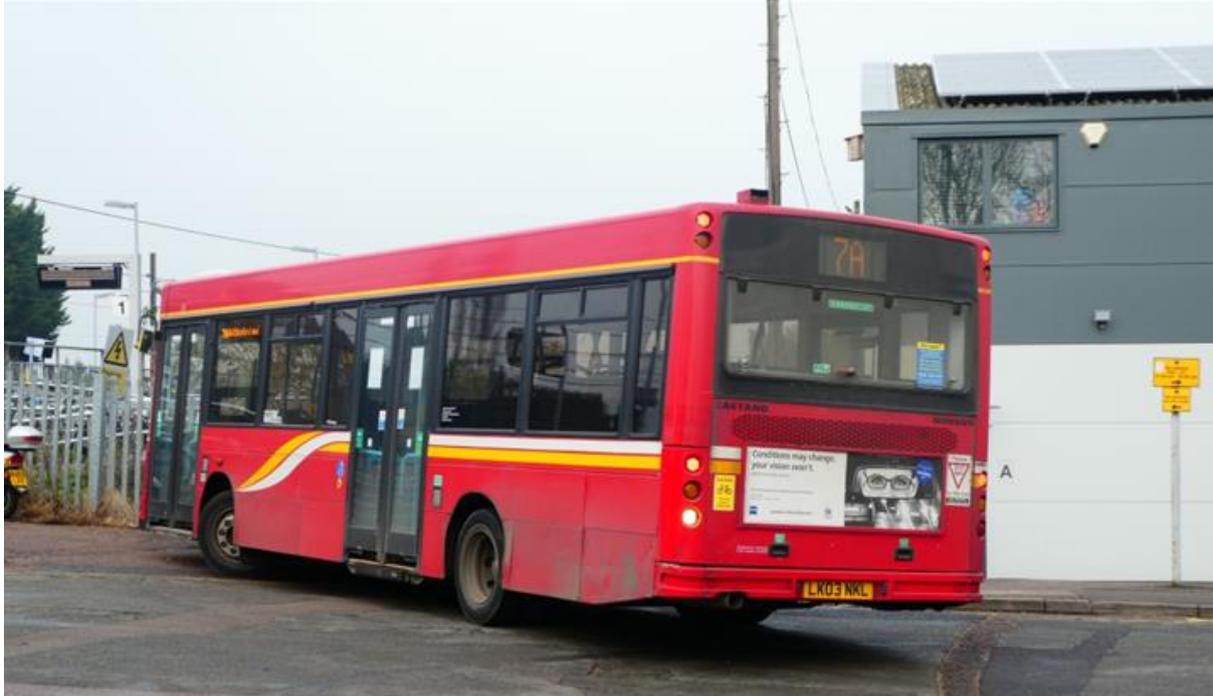
The 75A bus (every 75 minutes) also uses this road. There is no proper place to turnaround or a bus waiting shelter. The lack of pavement means that any passengers with restricted mobility would have find it difficult to use the bus. During the visit we saw two buses arrive and depart, no passengers boarded or alighted at the station.

**Picture 3: The bus has arrived at the station and is attempting to do a three-point turn as there is no space for a turning circle.**

- Provide disabled parking spaces close to the station entrance.
- Provide a proper bus stop with shelter.
- Extend bus operating hours to enable a service that could be used by commuters with through ticketing from Sawston village and the Duxford Museum.

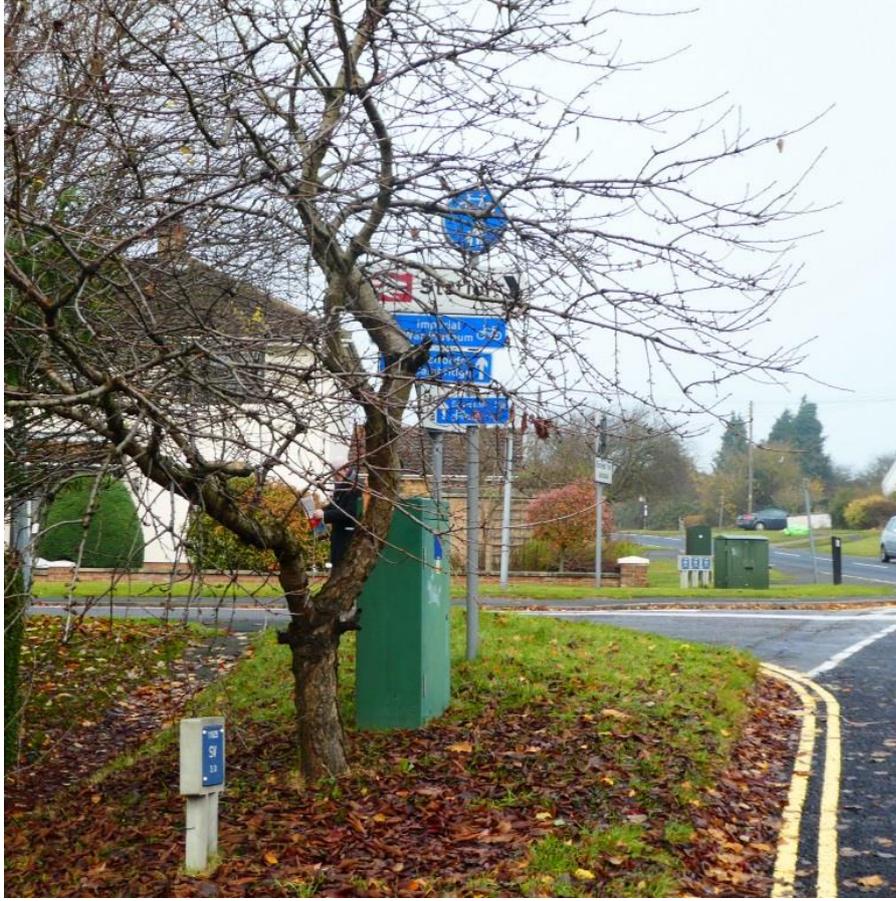
**Picture 4(A):** During the summer months, this sign to the station on the west approach road would be obscured by leaves.

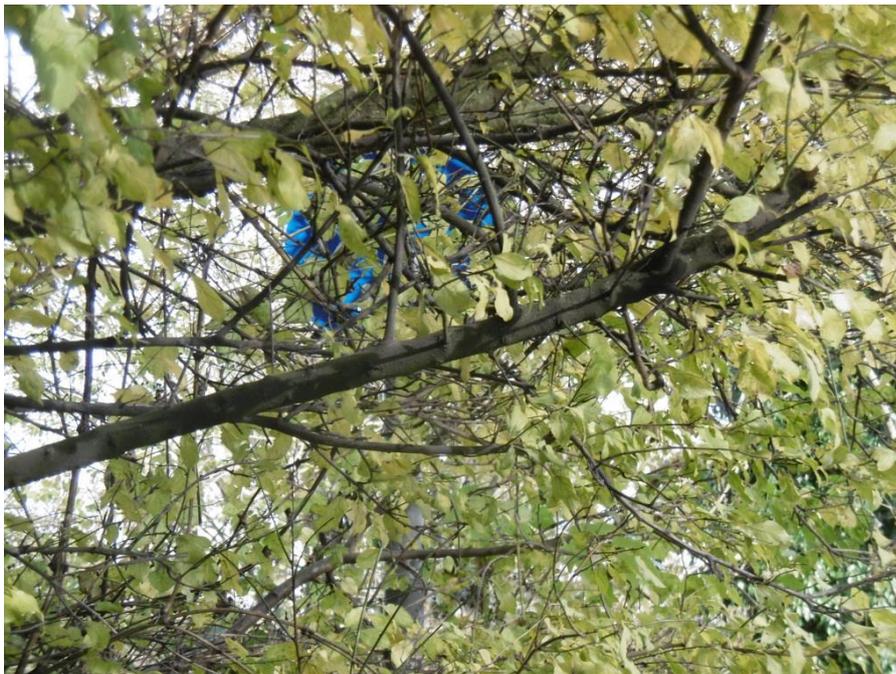
Pedestrian / cycle access to Duxford village requires crossing the A505. A central refuge is provided for pedestrians but no traffic lights on this 60mph road. The sign on Station Road West was obstructed by a tree.

**Picture 4(B):** Obscured sign

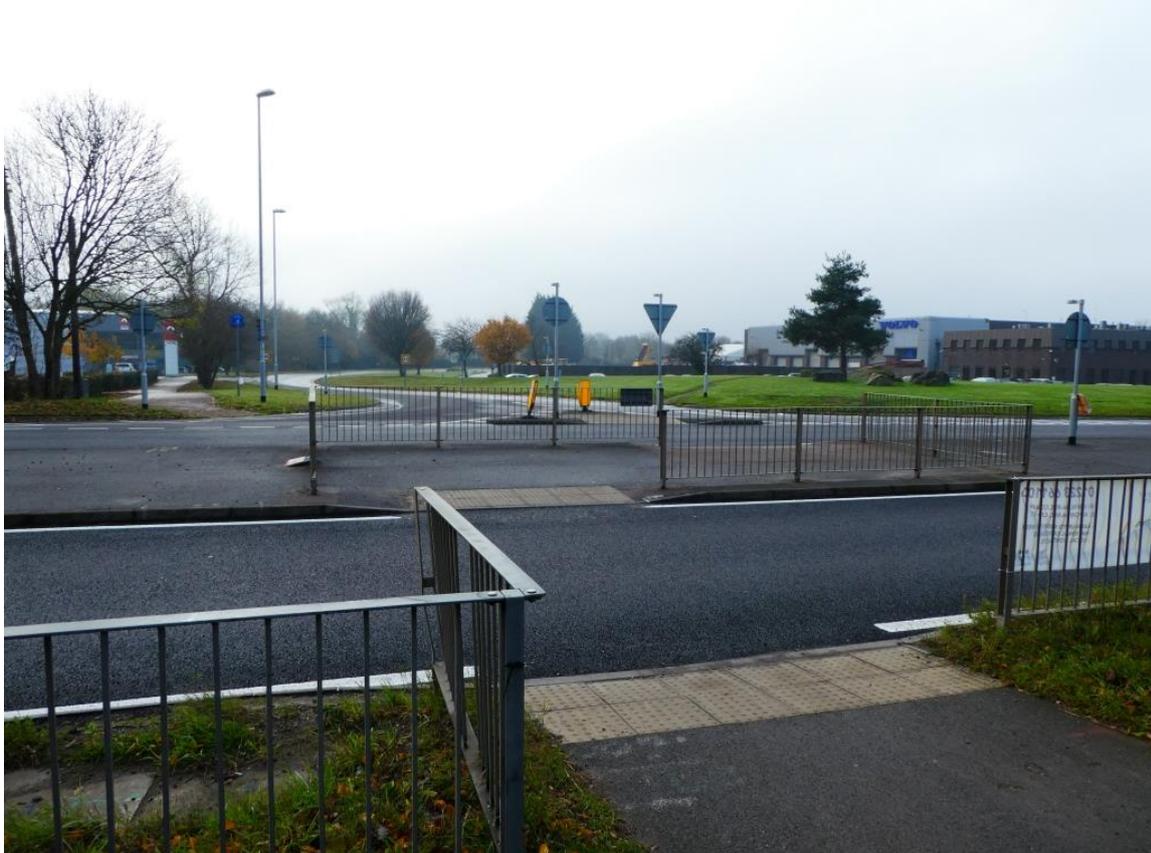
**Picture 4(C):** Pedestrians and cyclists wishing to access the station from Duxford Village have to cross the busy A505 road. A central refuge is provided but no traffic lights.

- Provide better signage and maps for arriving passengers towards local villages and Duxford Museum.
- Consider safety improvements for pedestrians / cyclists crossing the A505 to and from Duxford village.

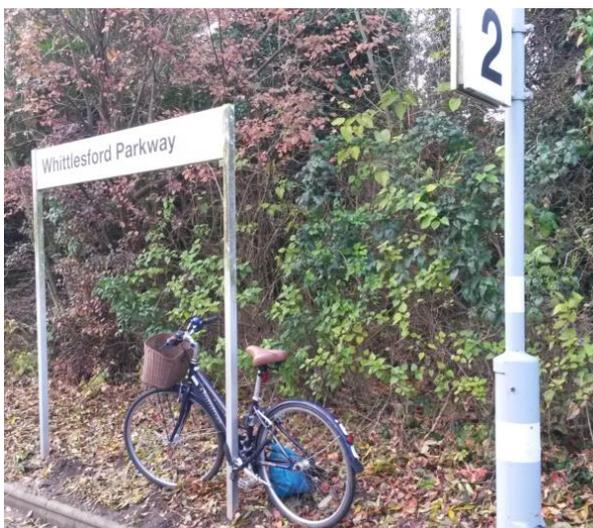
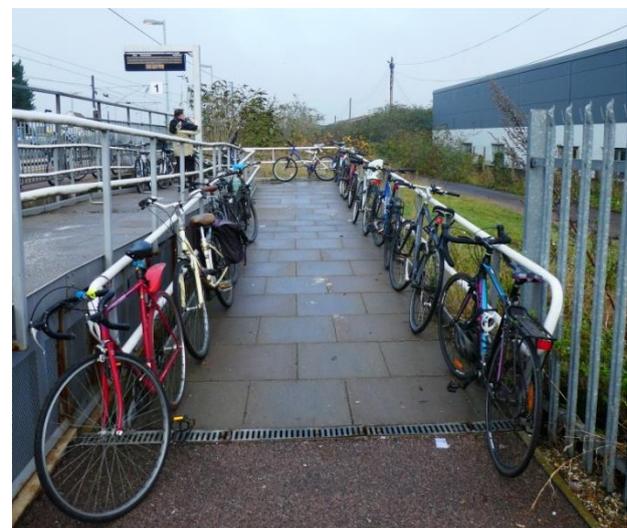
A limited number of cycle racks are provided on the west side of the station and on the down platform (2). These are inadequate which has resulted in cycles being left locked to railings, signage and lamp posts. There are no cycle racks on the east side and cycles are left locked to the disabled access ramp and platform railings (adjacent to platform 1).

**Picture 5(A):** A lack of racks causes cycles chained to be chained to signage (left) and the ramp on the up platform (right) make it difficult of disabled passengers to use the ramp.

- Provide additional secure and covered cycle parking on each side of the station. Possible sites include the grass area adjacent to the access current ramp on the up platform and by removing the shrub area between the station building and the A505 on the down platform.

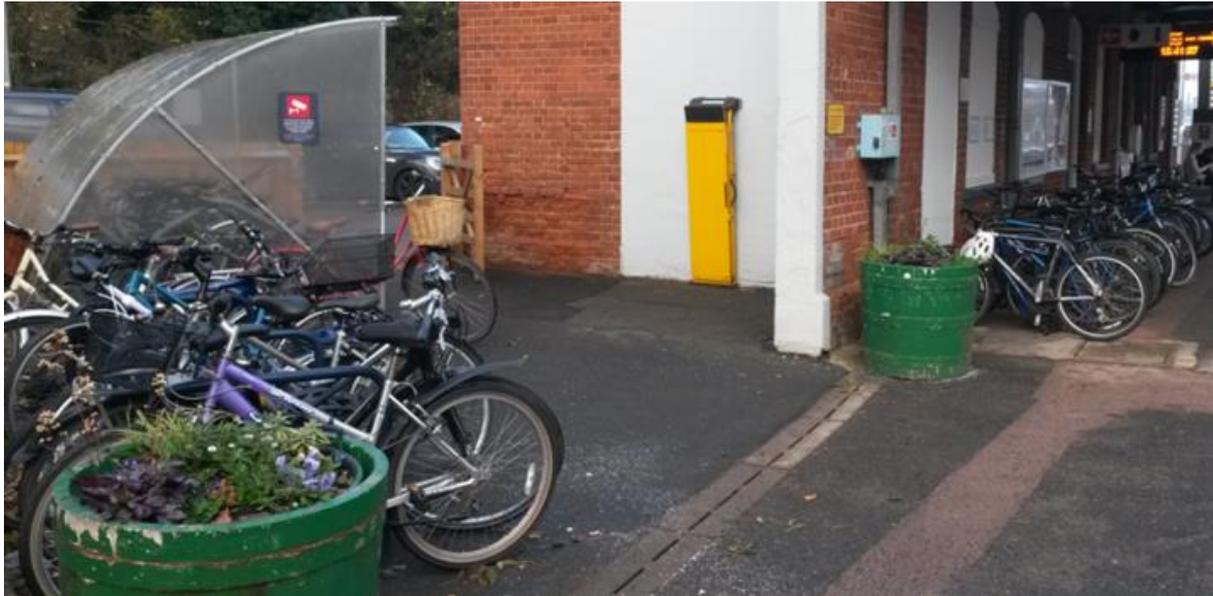
**Picture 5(B):** A small covered cycle rack is provided on the down platform but the majority of the cycles are secured using racks under the canopy.

- Remove cycle racks under station building canopy (down side) to increase shelter available to passengers. Provide additional seating under canopy.
- Additional platform shelters at the Cambridge end of each platform.
- Lifts up to the footbridge are an absolute imperative to assist mobility impaired passengers.
- Review signage to provide a consistent strategy and avoid signs obstructing each other.
- Additional platform customer information screens towards the Cambridge end of the platforms.
- Repairs to stair handrail and “mind the gap” signs on platforms.

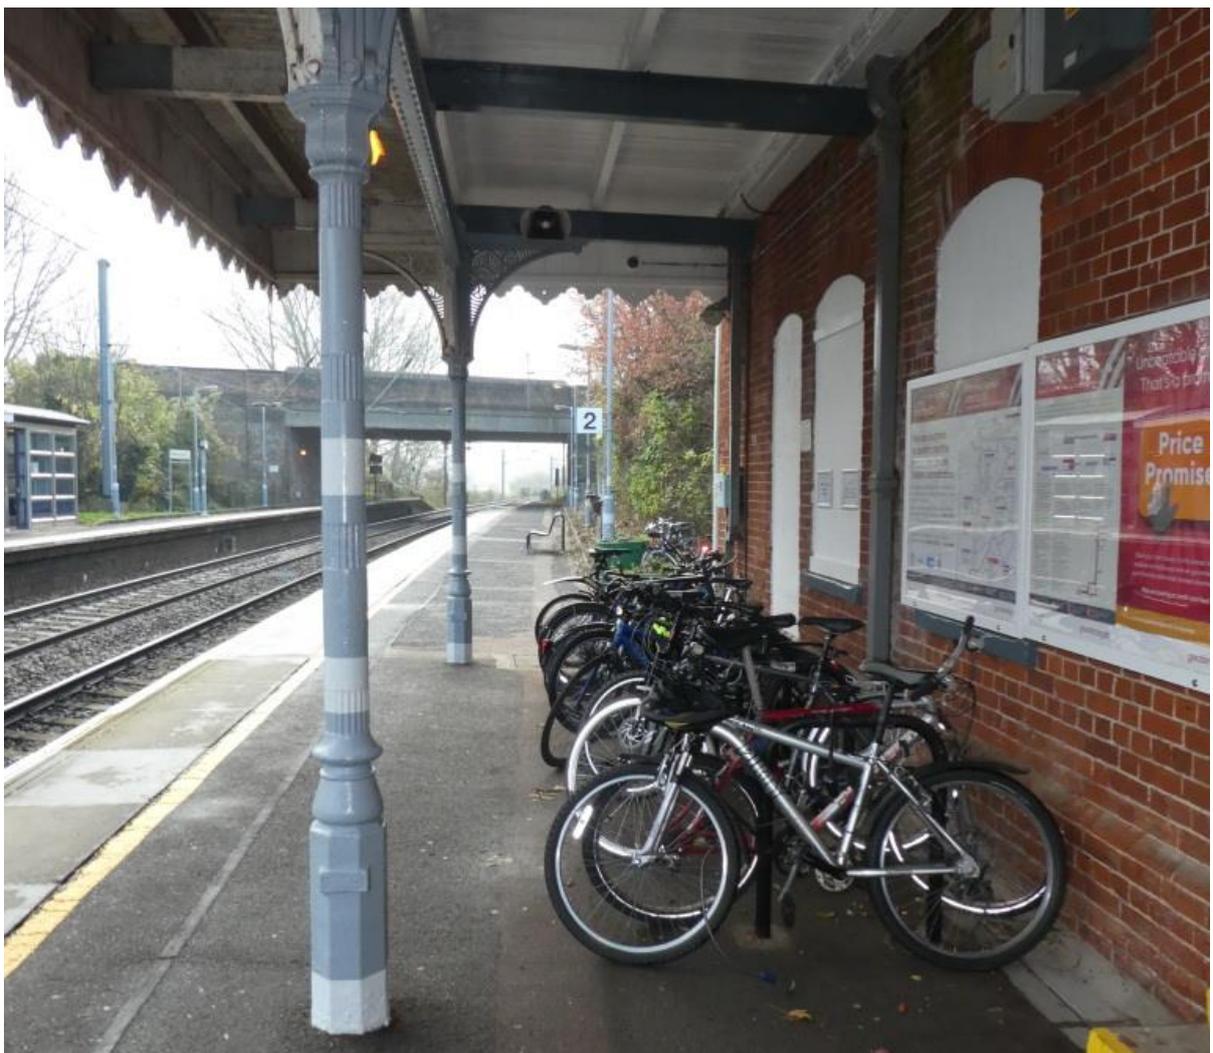
**Picture 5(C):** Relocating racks from under canopy would provide additional shelter for passengers.

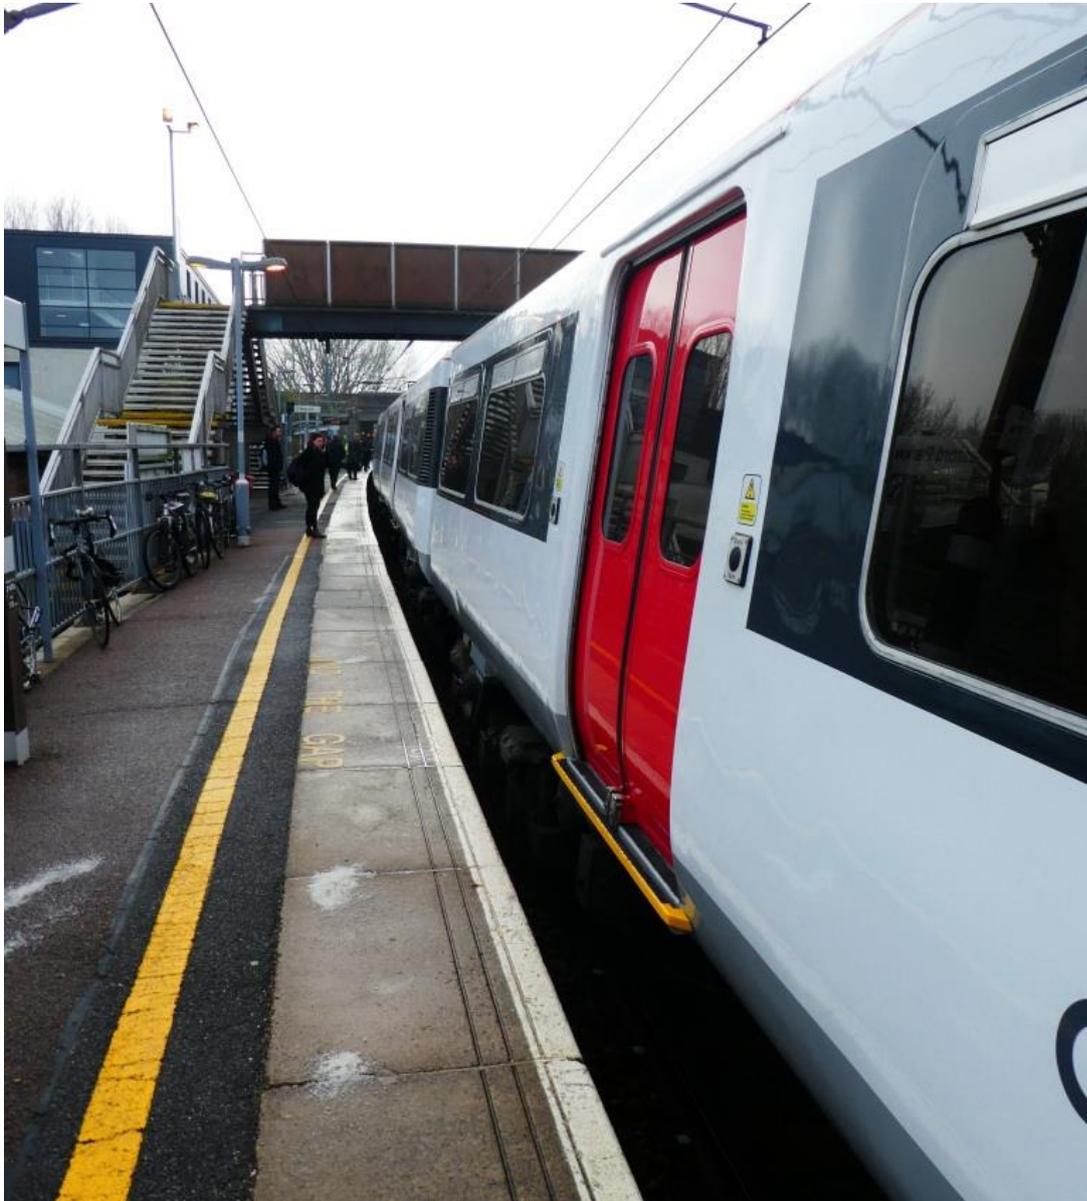
The station has 2 x 12-coach length platforms that are on a curve. Platform height is low and combined with the curve, creates a significant gap which can make boarding and alighting trains difficult.

**Picture 6(A):** The up platform. There is a large gap, both in height and distance between the platform edge and the train.

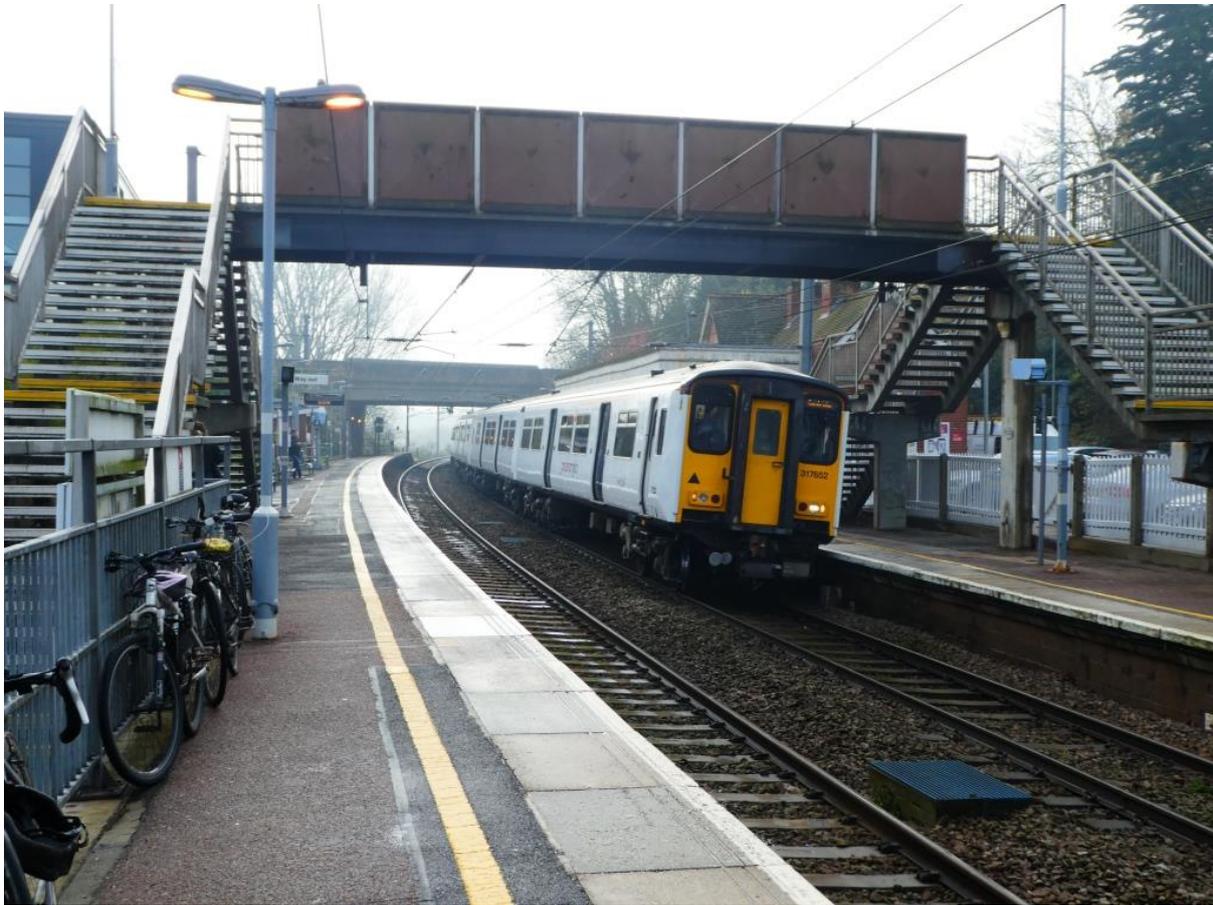
The platforms have yellow lines close to the platform edge but no tactile paving. The platforms are narrow in places and that width is further reduced by signage, OHLE stanchions, driver dispatch screens and cycles chained to fences.

**Picture 6(B): Parts of the up platform are narrow - cycles chained to the fence make this worse.**

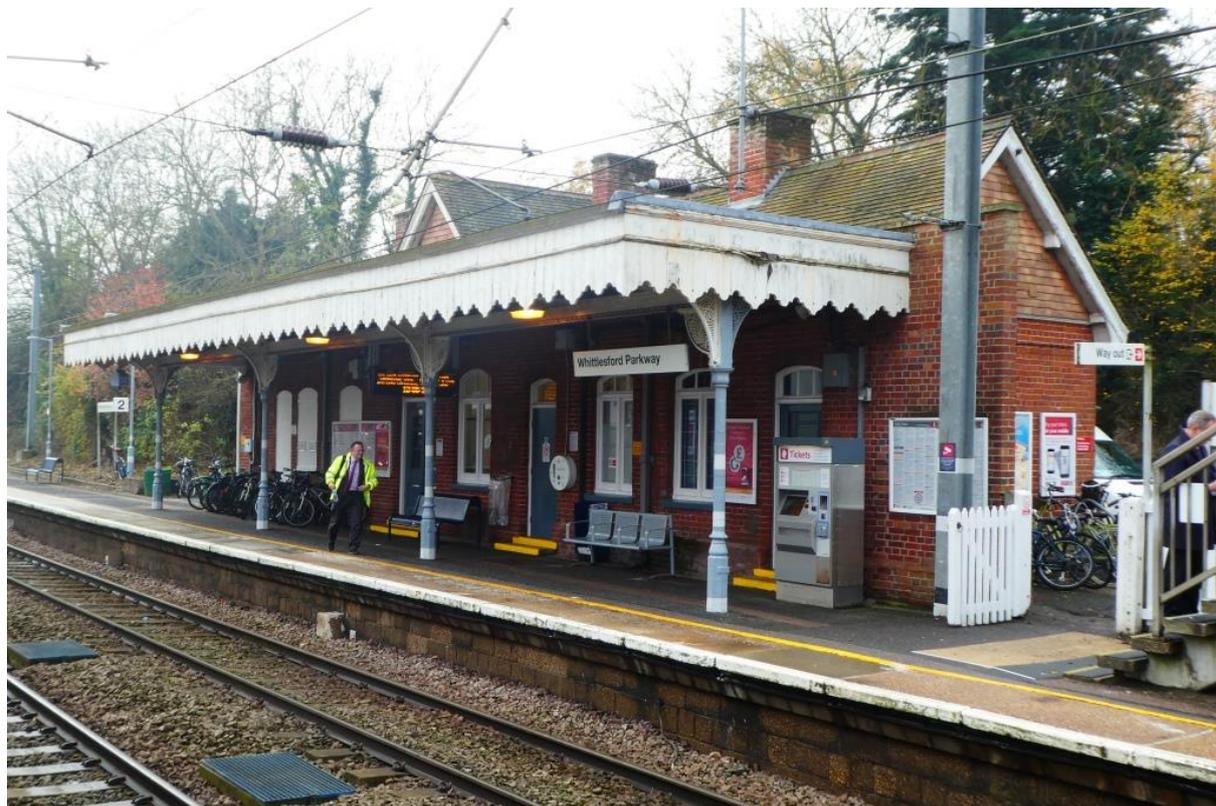
**Picture 7(B): Overall view of the main station building.**

The station building canopy provides shelter on the down platform but the effective area is reduced due to cycle parking. The shelter is around one railway coach long and there are no other shelters on the down platform.

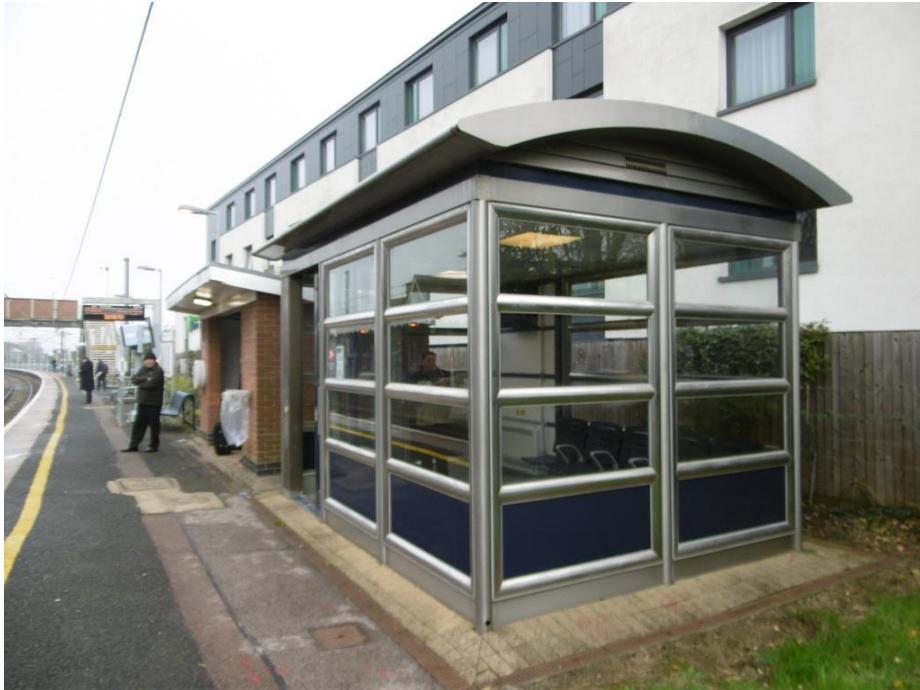
The up platform has a brick-built shelter and a more modern enclosed and heated waiting area. These cover around one coach length of the 12-coach platform. The automatic door on the modern shelter was not working and there was a puddle on the floor from a leaking roof.

**Picture 9(A): Brick-built shelter and a more modern enclosed waiting area on up platform.**

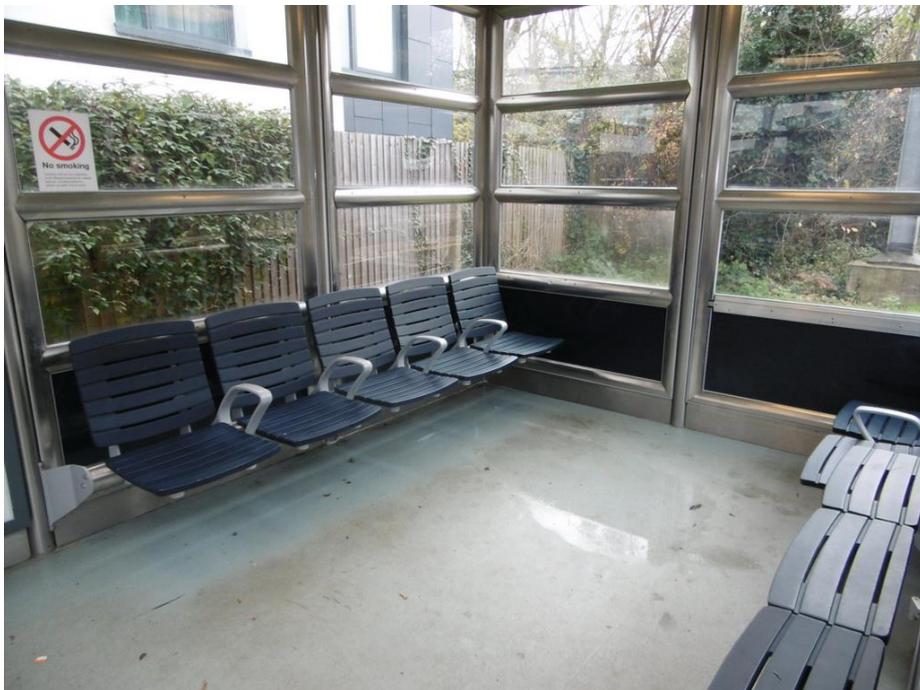
**Picture 9(B): Enclosed and heated waiting area on up platform with puddle on floor.**

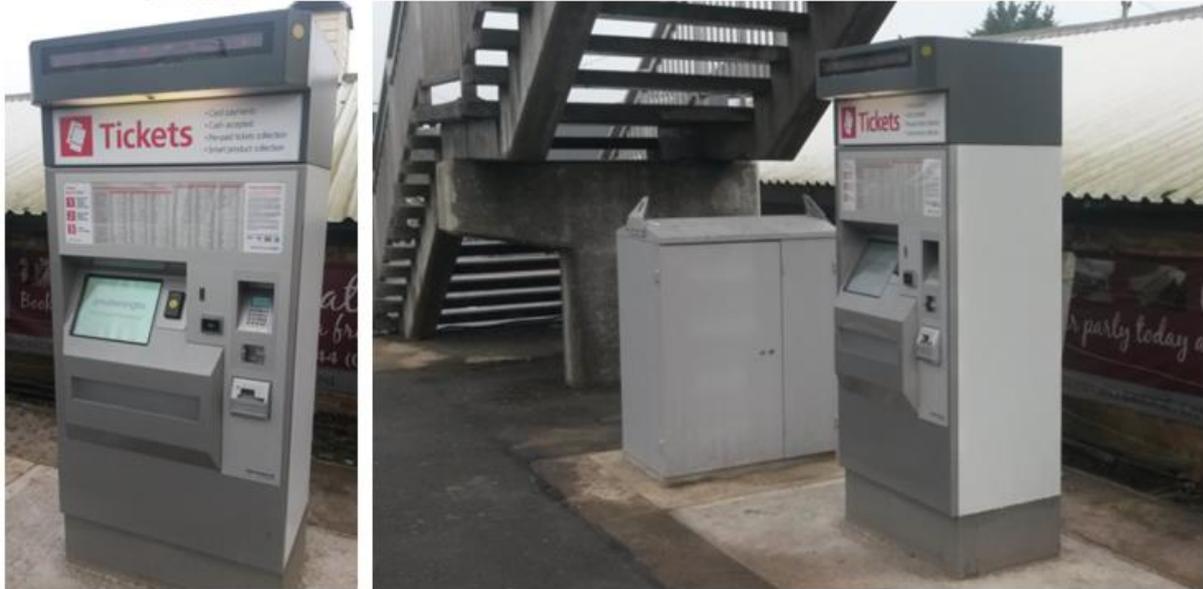
A ticket machine is provided on each platform – located under the canopy on the down platform and under the stairs on the up platform. It was noted that the machine allows for tickets to be brought for tomorrow after 12.00am. This should state 12.00 noon for clarity.

**Picture 10: Views of the TVM on the up platform.**

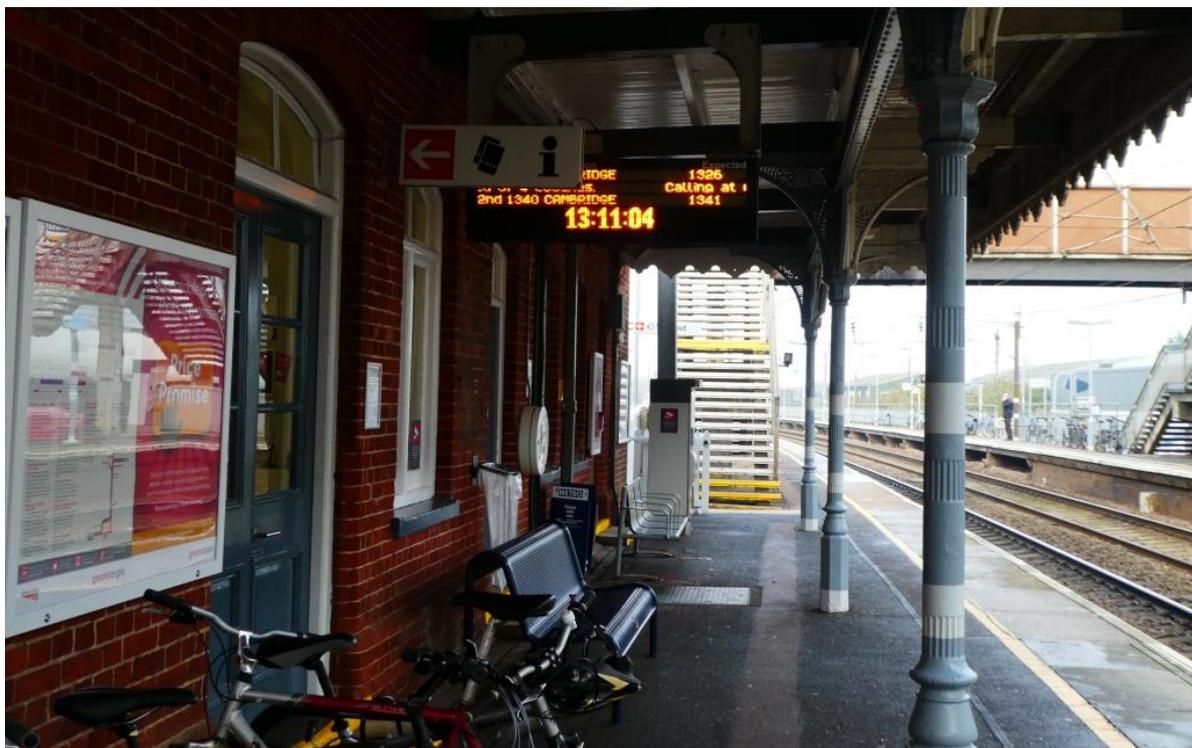
Departure screens at both entrances but difficult to read. Dot-matrix displays showing next three services on each platform but not visible on entire length of platform and are partly obscured by other signage.

**Picture 11: Part of the customer information screen is obstructed by other signage.**

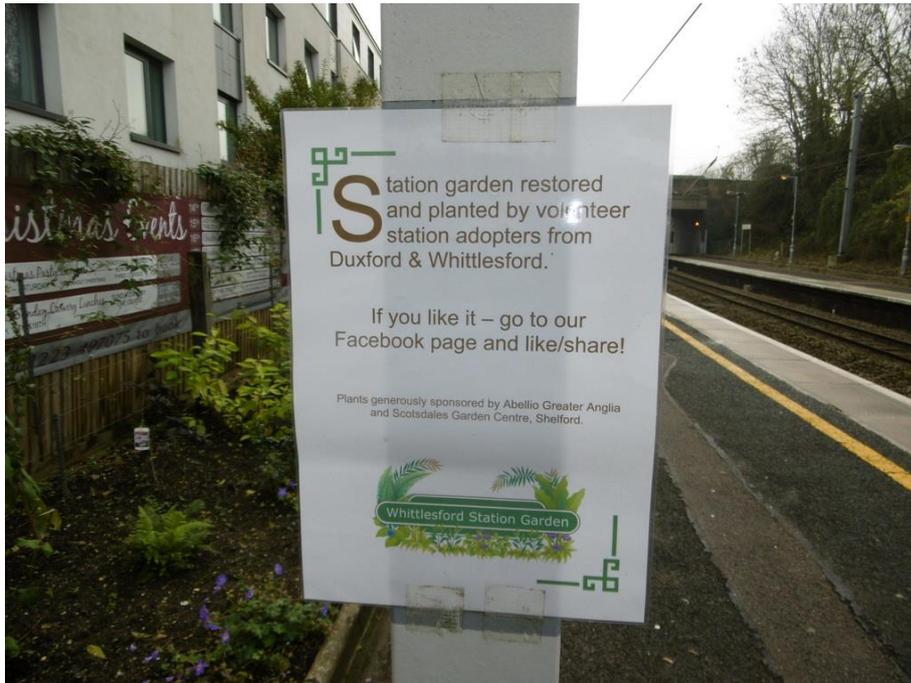
The up platform has a pleasant small community garden area looked after by the station adopters.

**Picture 12: Information about the community garden area.**

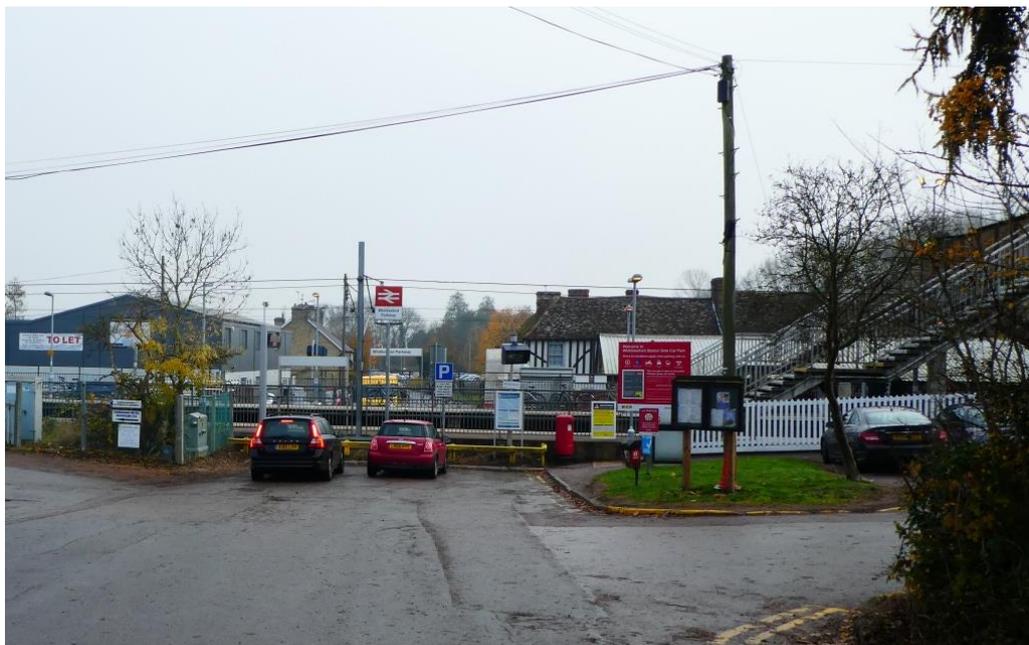
Signage on the station, like many other stations has evolved over the years and lacks consistency and is generally not very helpful. For example, for passengers arriving on the west side, it is not clear that access to the ticket office is via the platform. For passengers alighting from trains, signage to the bus stop or directions to local villages is non-existent. The local maps provided only show a few local roads and do not show the location of surrounding villages or recent housing development close to the station.

**Picture 13(A): Station approach signage on the west side of the station – confusing and lacks presence.**

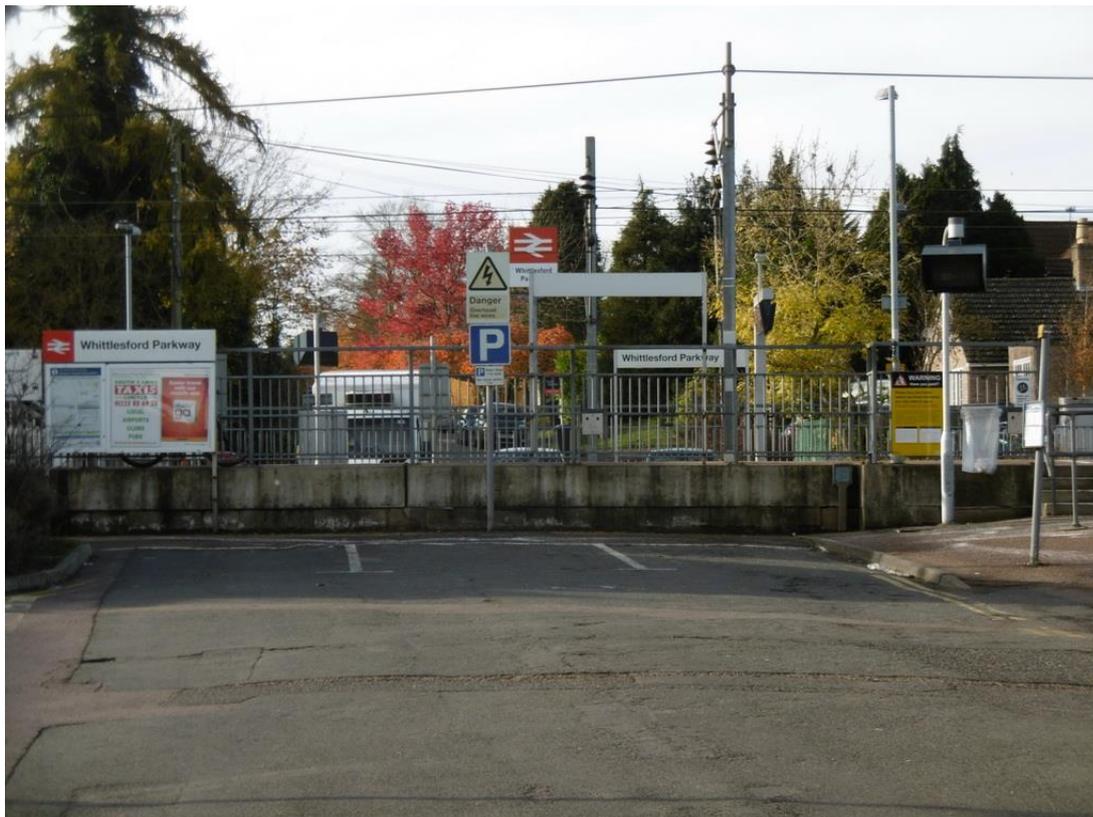
Picture 13(B): Station approach on the east side of the station

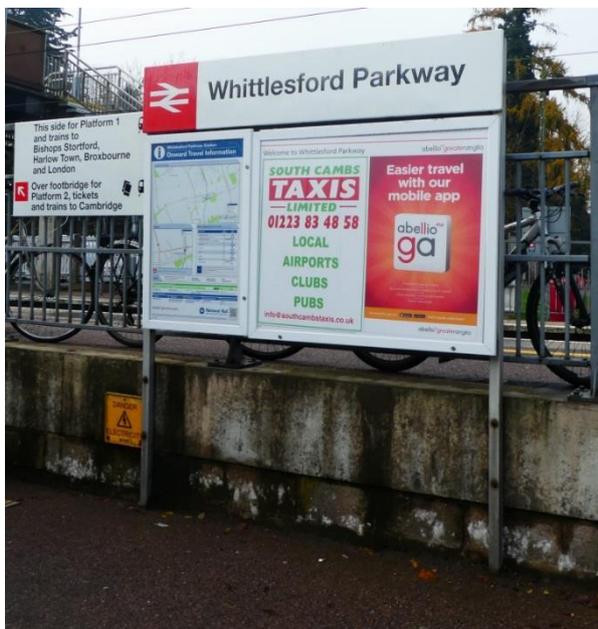
Picture 13(C): Station signs on the east side – the local map contains no useful information at all!

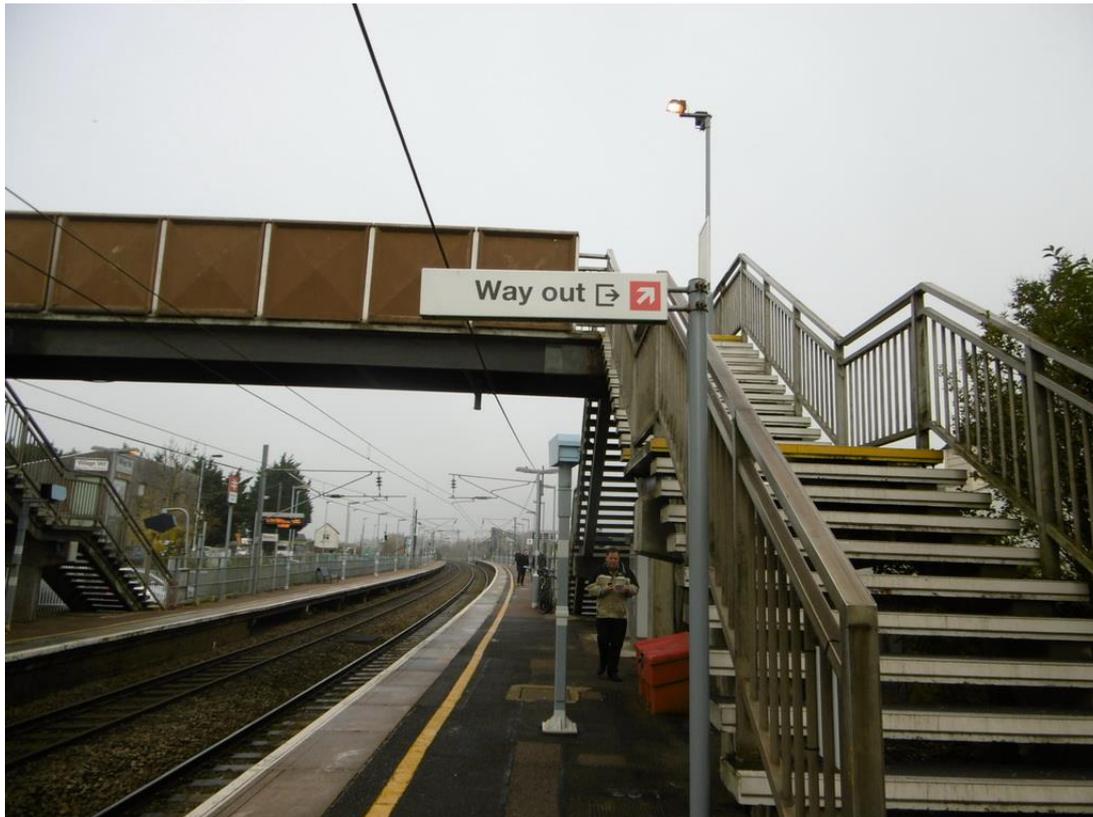
**Picture 13(D): On the up side signs indicate the way out is via the bridge with no indication of the east side exit at all. Very confusing!**

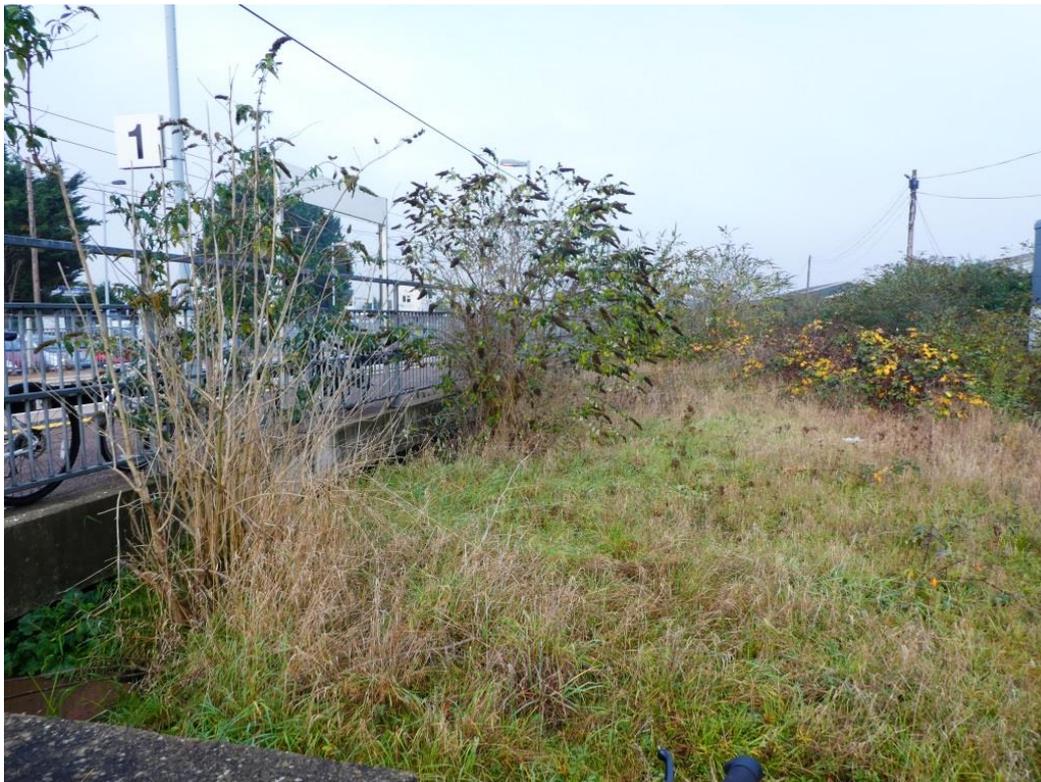
**Picture 14:** There is spare land adjacent to the up platform that could be used to provide a large covered cycle storage facility. Space could also be provided within this site for additional waiting shelters or a small coffee kiosk.

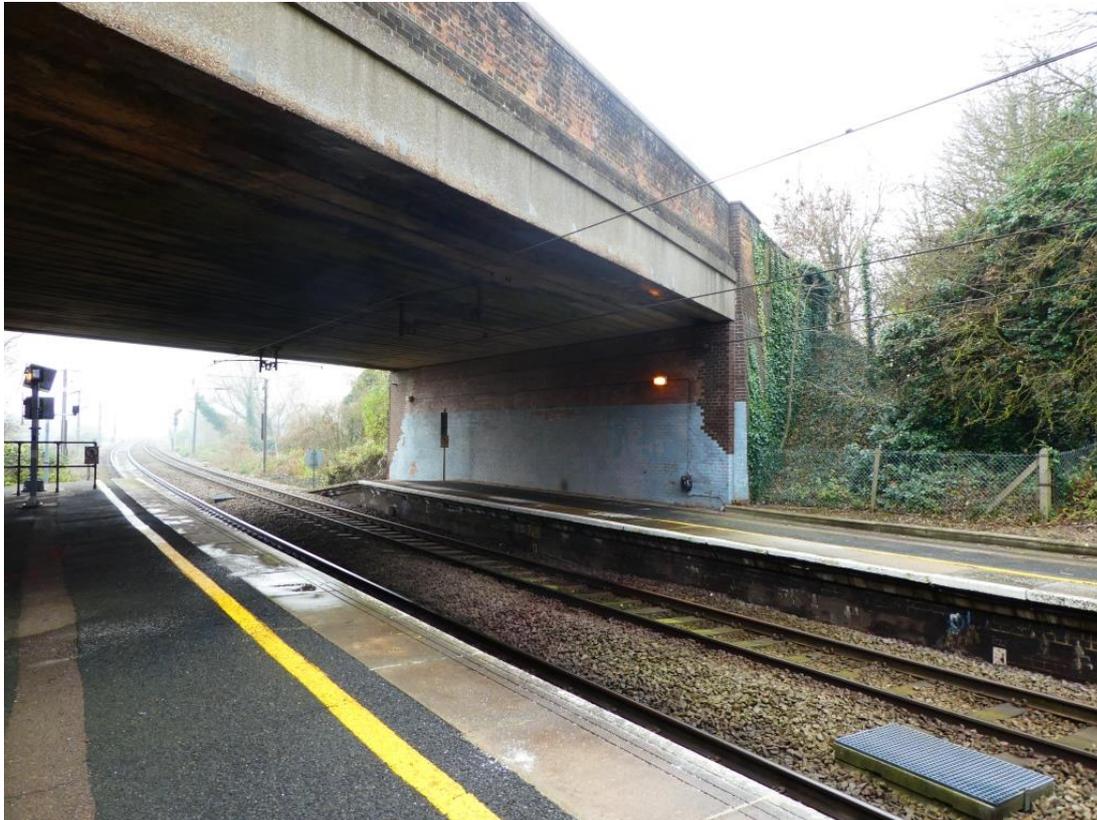
**Picture 14: The A505 bridge at the south end of the station. A footpath either side of the bridge to the road would provide better access to Duxford Village and could facilitate the provision of new bus stops on the main road.**

- Consider new path from end of down platform to south side of A505. This would provide a quicker and safer route to/from Duxford village. This may produce awkward sight lines for train drivers but this could possibly be overcome by dropping the footpath down almost to track level under the road bridge and fenced in tightly alongside the over-bridge's back wall with a short commensurate platform extension at its northern end.
